Volunteer Captain Dies in Engine Rollover - Colorado

SUMMARY

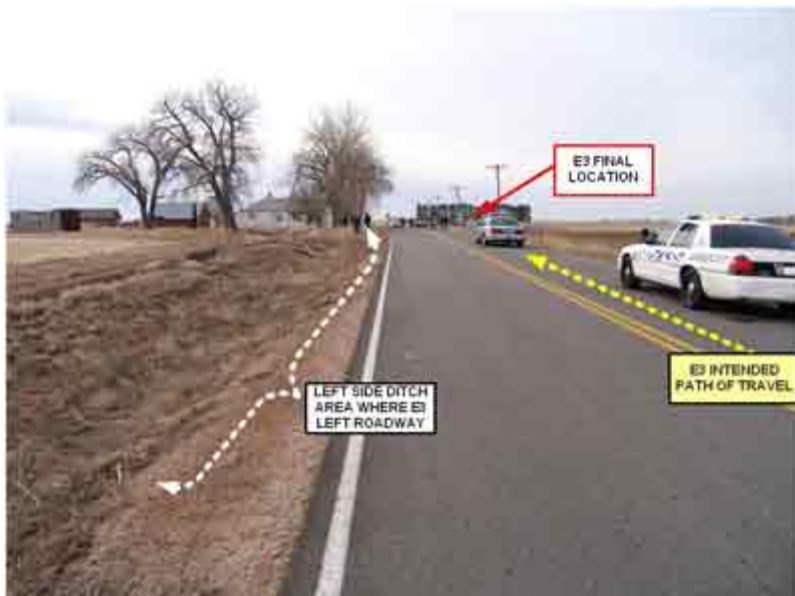
The two-lane asphalt roadway where the incident occurred runs north to south and is bordered by dirt shoulders. A white fog line is painted to the right of each lane with a double yellow line dividing the north/south lanes. To the west of the road there is a shallow irrigation ditch and to the east there is a deeper irrigation ditch ([Photo 3](#)). Both the road surface and the ditches were dry at the time of the crash. There is a posted speed limit of 55 MPH in the area.

Photo 3. View of the roadway where the incident occurred.
(Photo courtesy of the State Patrol)
